# Technical Note TN33

12<sup>th</sup> January 2011

## Control 15 Bios update

To fix bios checksum error and CD import issues on units shipped prior to 31<sup>st</sup> December 2010

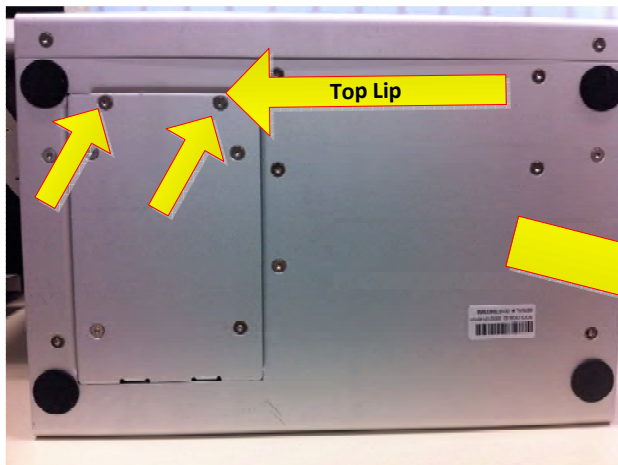
To gain access to hard drive remove screws (2 x Torx T10) as shown in picture below. Drive will come out from unit with a little force on the top lip.

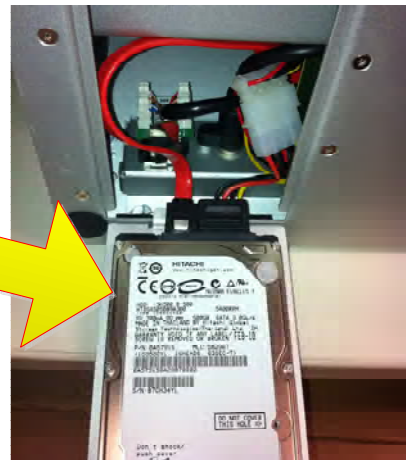
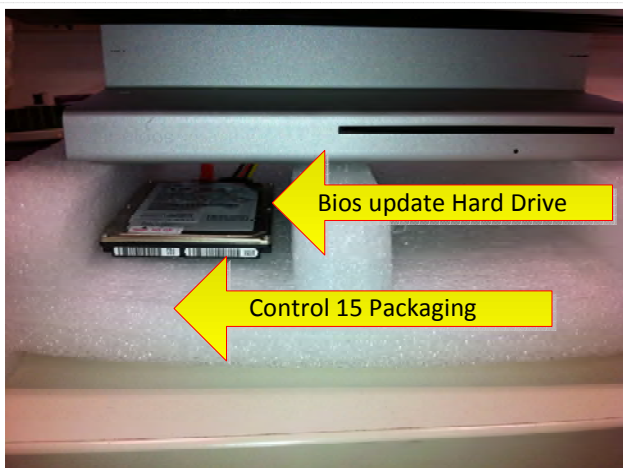
Remove drive connectors so drive can be removed, This drive needs to be retained to be put back into the unit once the update has been done.

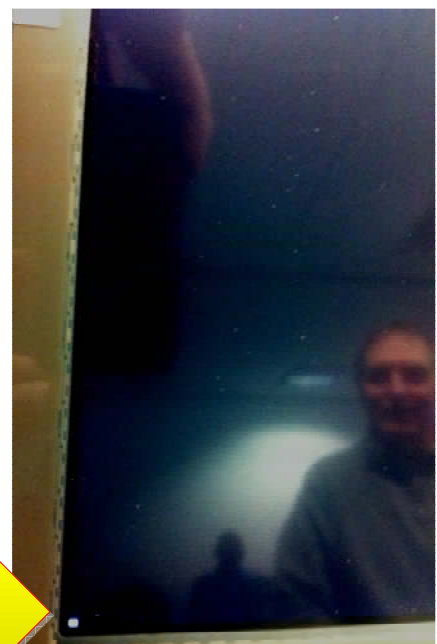
During boot, the "M" Logo will appear and you should be able to see a small white dot in the left hand corner of the display as pictured.

White Dot indicates latest bios update
